**Flood Control Project Maintenance
Levee Inspections**

Fall 2015 Levee Maintenance Deficiency Summary Report

Reclamation District No. 1660 Tisdale

Levee Inspection Report By Mile - Fall 2015

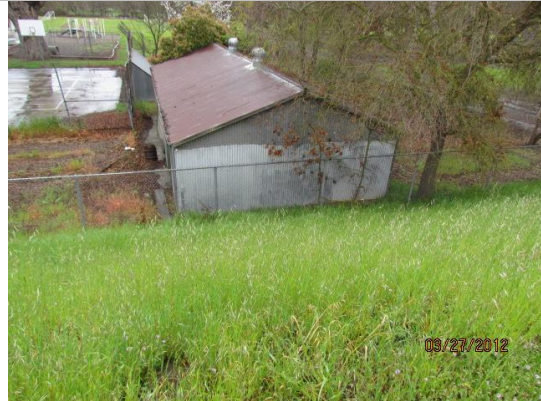
Photo 1 of 1 : FA_2015_RD1660_8_12_20150910_00005.jpg

LM Start	0.05	Rating **	M	Issue No.	12
LM End	0.05	Issue Type +	En	Location *	LS
Category	Earthen Levee			GPS Latitude/Longitude	
				Start	End
Item	Encroachments			39.062643 °	39.062643 °
				-121.837857 °	-121.837857 °
DWR ID	DWR_RD1660_01_s_2012_12				
Action/Comments					
Building

View of the building and fence at the landside toe.

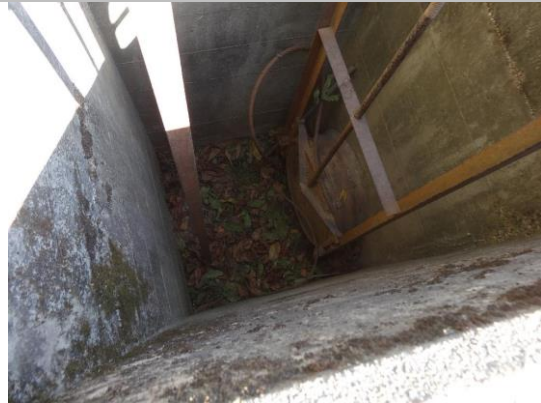
Photo 1 of 3 : UCIP_FA_2015_2479.jpg

LM Start	0.14	Rating **	M	Issue No.	20
LM End	0.14	Issue Type +	En	Location *	LS
Category	Supplemental			GPS Latitude/Longitude	
				Start	End
Item	DWR UCIP Field Study			39.061322 °	39.061322 °
				-121.837993 °	-121.837993 °
DWR ID					
Action/Comments					
Inspector Comments: FS_ID:46670					
DS_ID:22489					
EP_NO: N/A					
FS_HLM: 0.142					
Repair Type: Non-Urgent					
Crossing Status: Found					
UCIP Comments: - needs proper abandonment.- opening of landside pipe almost buried.					
FIELD_STRUCT_DESC: *ABANDONED* 24-inch pipe thru levee, 16.4					
FBC. Slide gate in concrete well at toe of WW slope. (IV A-Winship).					
USACE bench mark on top of headwall at LS toe. O&M Manual SAC					
133, August 1955.					
FS Date: 10/10/2013

WS view: closer view of two slide gates in concrete box on levee slope.

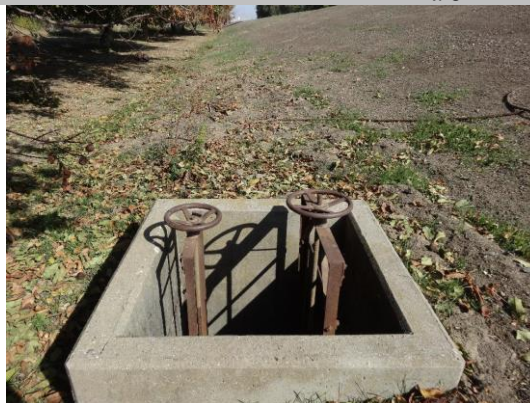
Photo 2 of 3 : UCIP_FA_2015_2480.jpg

Action/Comments					
Inspector Comments: FS_ID:46670 DS_ID:22489 EP_NO: N/A FS_HLM: 0.142 Repair Type: Non-Urgent Crossing Status: Found UCIP Comments: - needs proper abandonment.- opening of landside pipe almost burried. FIELD_STRUCT_DESC: *ABANDONED* 24-inch pipe thru levee, 16.4 FBC. Slide gate in concrete well at toe of WW slope. (IV A-Winship). USACE bench mark on top of headwall at LS toe. O&M Manual SAC 133, August 1955. FS Date: 10/10/2013

WS view: two slide gates in concrete box on levee slope.

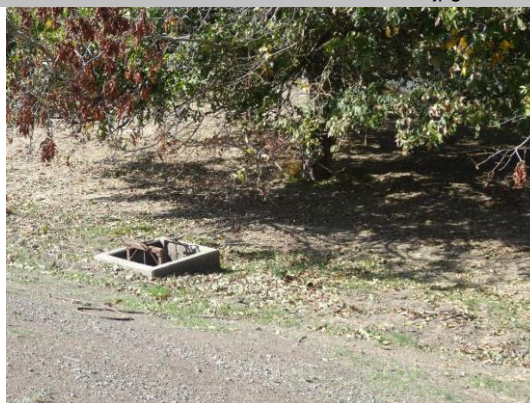
Photo 3 of 3 : UCIP_FA_2015_2481.jpg

WS view: concrete box on levee slope. No pipe found on berm and river bank.

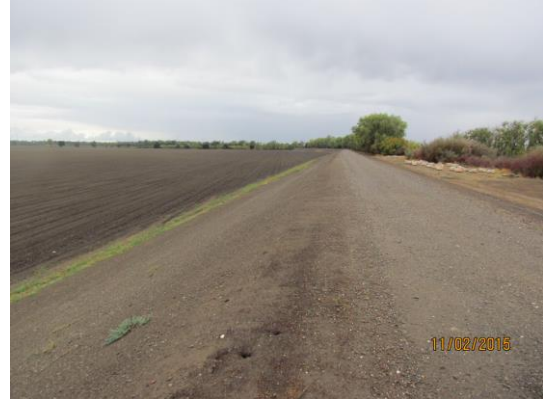
Photo 1 of 1 : FA_2015_RD1660_8_18_20151118_00011.jpg

LM Start	0.42	Rating **	A	Issue No.	18
LM End	0.42	Issue Type +	Ma	Location *	LS
Category	Earthen Levee			GPS Latitude/Longitude	
				Start	End
Item	Vegetation			39.057275 °	39.057275 °
				-121.838695 °	-121.838695 °
DWR ID	DWR_RD1660_01_f_2015_18				
Action/Comments					
Control annual grass and weeds on the levee slopes and easements. Inspector Comments: The Reclamation District burns and drags both slopes.

View of the levee with no vegetation on both slopes.

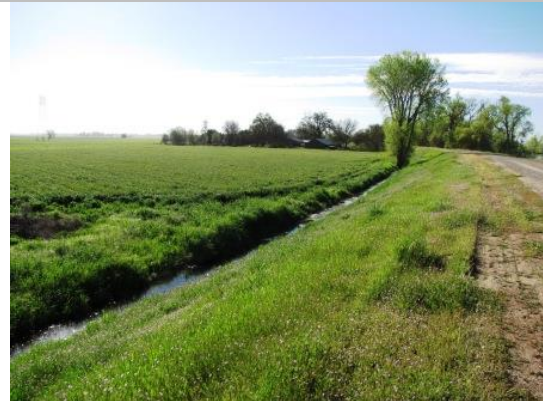
Photo 1 of 1 : FA_2015_RD1660_8_9_20150910_00004.jpg

LM Start	1.10	Rating **	M	Issue No.	9
LM End	1.40	Issue Type +	En	Location *	LS
Category	Earthen Levee			GPS Latitude/Longitude	
				Start	End
Item	Encroachments			39.047610 °	39.043622 °
				-121.838802 °	-121.836445 °
DWR ID	DWR_RD1660_01_s_2012_9				
Action/Comments					
Ditch

View of the ag ditch along the L/S toe.

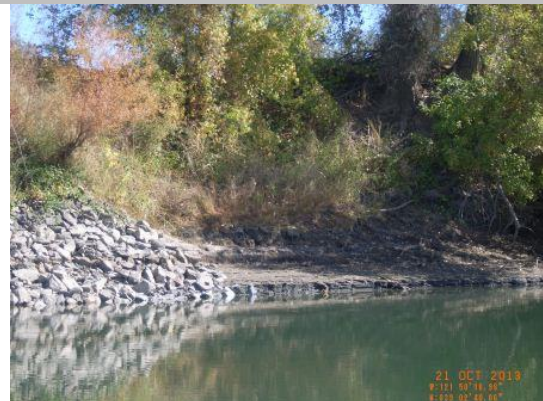
Photo 1 of 1 : USACE2013A_SAC_120-6_L_2.jpg

LM Start	1.33	Rating **	M	Issue No.	8
LM End	1.36	Issue Type +	Ma	Location *	WS
Category	Supplemental			GPS Latitude/Longitude	
				Start	End
Item	2015 USACE Erosion Survey, DRAFT			39.044361 °	39.043916 °
				-121.837654 °	-121.837305 °
DWR ID					
Action/Comments					
Inspector Comments: 2009 - Erosion on levee toe where an old cobble site is failing. 2011 - Some new minor erosion. 2012 - Site extended downstream, bank is being impacted from the weight of the trees. 2013 - Minor new erosion at the toe. 2015: Minor new erosion at the toe. [2015 Site ID: SAC_120-6_L]

USACE 2013 Photo #1

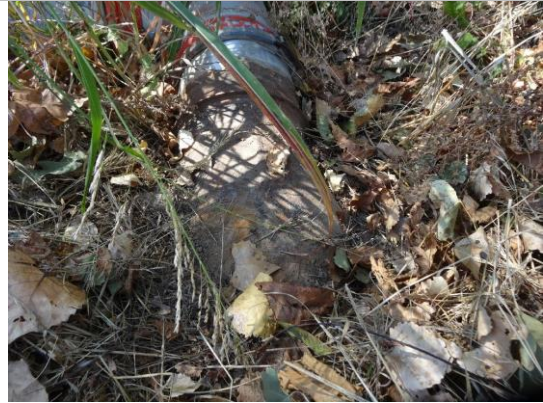
Photo 1 of 3 : UCIP_FA_2015_0695.jpg

LM Start	1.53	Rating **	M	Issue No.	21
LM End	1.53	Issue Type +	En	Location *	WS
Category	Supplemental			GPS Latitude/Longitude	
				Start	End
Item	DWR UCIP Field Study			39.042304 °	39.042304 °
				-121.834783 °	-121.834783 °
DWR ID					
Action/Comments					
Inspector Comments: FS_ID:22543 DS_ID:22484 EP_NO: 16476 FS_HLM: 1.561 Repair Type: Non-Urgent Crossing Status: Found UCIP Comments: - 16-inch old steel pipe abandoned. Abandoned pipe found on landside levee toe.- abandoned power pole on waterside.- mobile diesel pump on channel bank.- attached tin pipes exposed on levee surface. FIELD_STRUCT_DESC: 14-inch steel pipe through the levee crown, the placement of two 12-inch diameter tin pipes on the surface of the levee slopes attached to the existing 14-inch steel pipe. The pipe discharges into irrigation ditch on landside. An air vent on landside shoulder. (App. No. 16476 - Ettl, 1997). FS Date: 10/10/2013

WS view: two exposed tin pipes joined together and connected to 14-inch steel pipe on levee slope.

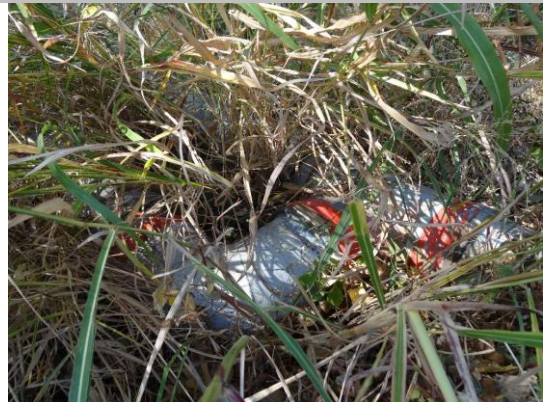
Photo 2 of 3 : UCIP_FA_2015_0696.jpg

WS view: two exposed 12" tin pipes on levee slope.

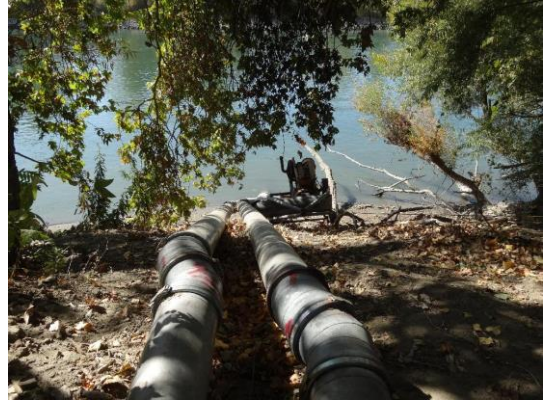
Photo 3 of 3 : UCIP_FA_2015_0697.jpg

LM Start	1.53	Rating **	M	Issue No.	21 (cont)
LM End	1.53	Issue Type +	En	Location *	WS
Category	Supplemental			GPS Latitude/Longitude	
				Start	End
Item	DWR UCIP Field Study			39.042304 °	39.042304 °
				-121.834783 °	-121.834783 °
DWR ID					
Action/Comments					
Inspector Comments: FS_ID:22543					
DS_ID:22484					
EP_NO: 16476					
FS_HLM: 1.561					
Repair Type: Non-Urgent					
Crossing Status: Found

WS view: two exposed 12" tin pipes on levee slope. These pipes connected to the pump on river bank.

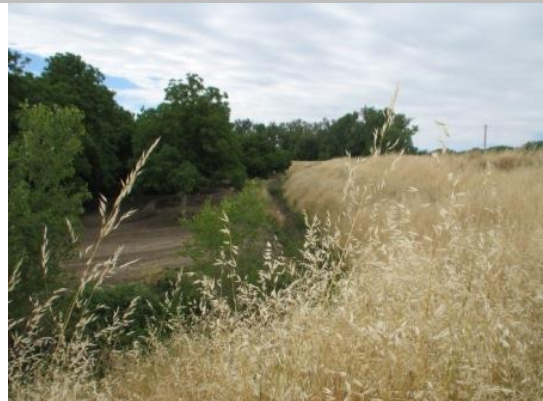
Photo 1 of 1 : FA_2015_RD1660_8_1_20150910_00001.jpg

LM Start	2.01	Rating **	M	Issue No.	1
LM End	2.34	Issue Type +	En	Location *	LS
Category	Earthen Levee			GPS Latitude/Longitude	
				Start	End
Item	Encroachments			39.037640 °	39.034416 °
				-121.828421 °	-121.825698 °
DWR ID	DWR_RD1660_01_s_2012_1				
Action/Comments					
Ditch

View of the large ditch along the landside toe.

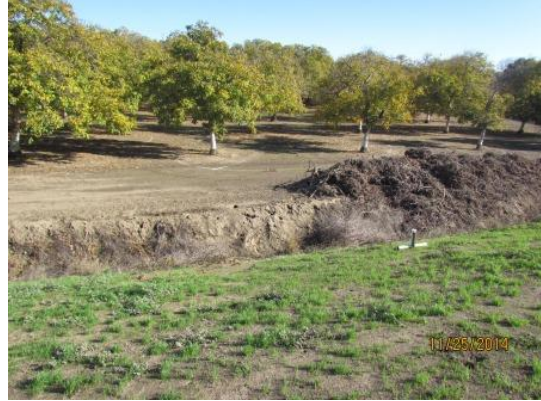
Photo 1 of 1 : FA_2015_RD1660_8_19_20150910_00007.jpg

LM Start	2.16	Rating **	M	Issue No.	19
LM End	2.16	Issue Type +	Ma	Location *	LS
Category	Earthen Levee			GPS Latitude/Longitude	
				Start	End
Item	Animal Control			39.035420 °	39.035420 °
				-121.828530 °	-121.828530 °
DWR ID	DWR_RD1660_01_f_2014_19				
Action/Comments					
No rodents visible, but rodent burrows visible; need to backfill and compact or grout burrows.					
Inspector Comments: Repair the rodent holes on the landside slope.

View of the rodent holes and bait station.

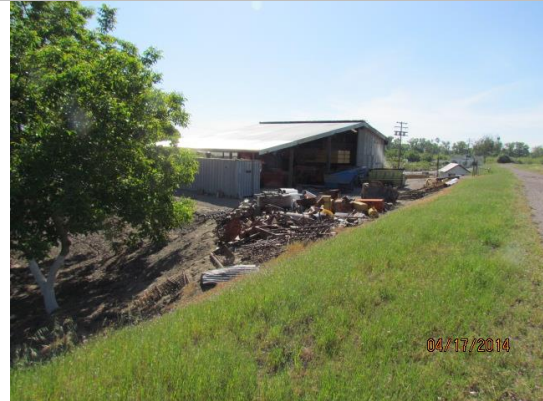
Photo 1 of 1 : FA_2015_RD1660_8_3_20150910_00002.jpg

LM Start	2.58	Rating **	M	Issue No.	3
LM End	2.58	Issue Type +	Ma	Location *	LS
Category	Earthen Levee			GPS Latitude/Longitude	
				Start	End
Item	Encroachments			39.031405 °	39.031405 °
				-121.823403 °	-121.823403 °
DWR ID	DWR_RD1660_01_s_2012_3				
Action/Comments					
Equipment

View of equipment along the landside slope.

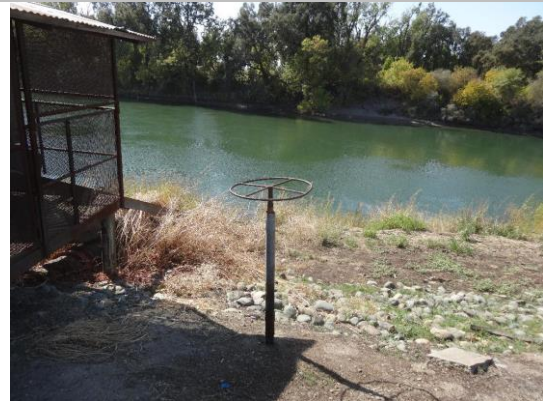
Photo 1 of 3 : UCIP_FA_2015_0556.jpg

LM Start	2.62	Rating **	M	Issue No.	22
LM End	2.62	Issue Type +	En	Location *	LS
Category	Supplemental			GPS Latitude/Longitude	
				Start	End
Item	DWR UCIP Field Study			39.030935 °	39.030935 °
				-121.823022 °	-121.823022 °
DWR ID					
Action/Comments					
Inspector Comments: FS_ID:22632					
DS_ID:22492					
EP_NO: 10012					
FS_HLM: 2.671					
Repair Type: Non-Urgent					
Crossing Status: Found					
UCIP Comments: - abandoned pumphouse on landside toe. Needs confirmation from LMA or DWR Inspector about abandonment of pumphouse.- headwall on channel bank.					
FIELD_STRUCT_DESC: 24-inch steel pipe through levee, 24 feet below crown. Slide gate on waterward shoulder. Abandoned pumphouse at landward slope. (ABO No. 10012-Harris)					
FS Date: 10/10/2013

WS view: gate valve handle (center) on levee slope.

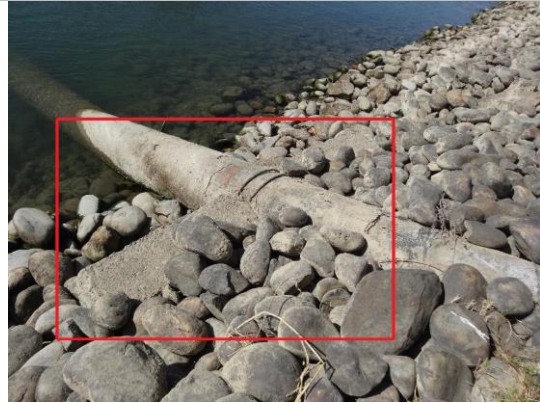
Photo 2 of 3 : UCIP_FA_2015_2274.jpg

Inspector Comments: FS_ID:22632
 DS_ID:22492
 EP_NO: 10012
 FS_HLM: 2.671
 Repair Type: Non-Urgent
 Crossing Status: Found
 UCIP Comments: - abandoned pumphouse on landside toe. Needs confirmation from LMA or DWR Inspector about abandonment of pumphouse.- headwall on channel bank.
 FIELD_STRUCT_DESC: 24-inch steel pipe through levee, 24 feet below crown. Slide gate on waterward shoulder. Abandoned pumphouse at landward slope. (ABO No. 10012-Harris)
 FS Date: 10/10/2013

WS view: closer view of inlet steel pipe immersed into channel water.
 Pipe was supported by concrete headwall.

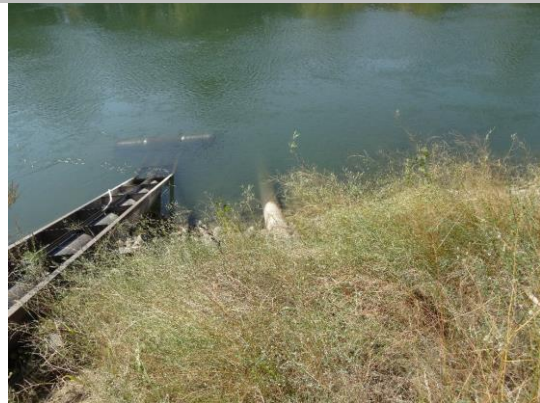
Photo 3 of 3 : UCIP_FA_2015_2275.jpg

WS view: inlet steel pipe (right) immersed into channel water.

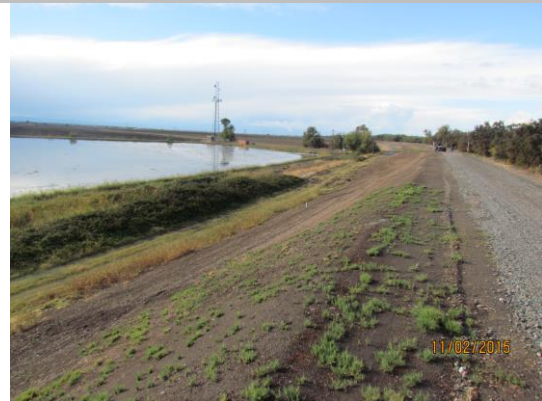
Photo 1 of 1 : FA_2015_RD1660_9_8_20151118_00006.jpg

LM Start	4.98	Rating **	A	Issue No.	8
LM End	4.98	Issue Type +	Ma	Location *	LS
Category	Earthen Levee			GPS Latitude/Longitude	
				Start	End
Item	Animal Control			39.101095 °	39.101095 °
				-121.773612 °	-121.773612 °
DWR ID	DWR_RD1660_02_f_2015_8				
Action/Comments					
Exterminate rodents and backfill and compact or grout burrows. Inspector Comments: The Reclamation District repaired the rodent holes.

View of the repaired rodent holes.

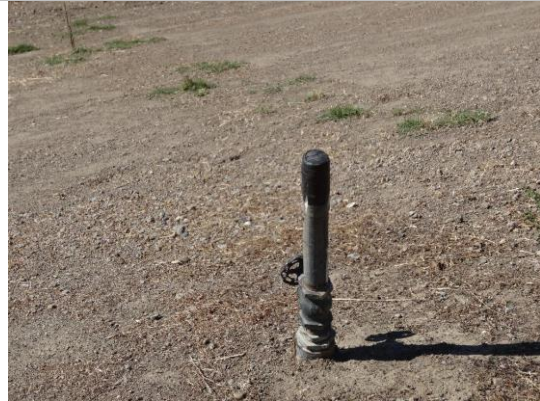
Photo 1 of 3 : UCIP_FA_2015_2381.jpg

Inspector Comments: FS_ID:22705
 DS_ID:22499
 EP_NO: N/A
 FS_HLM: 5.115
 Repair Type: Non-Urgent
 Crossing Status: Found
 UCIP Comments: Pressure relief valve on landside levee slope. Pump platform under construction for upgrade (raising platform) Look for new upgrade/revision permit.
 FIELD_STRUCT_DESC: 18-inch steel pipe through the levee, 5.8 feet below crown. Pump in channel. Gate valve on the landward berm. Discharges into 4-foot by 4 foot concrete box on the landward berm. 2-inch electric conduit through the levee, 3.0 feet below the crown.
 (Permit No. 4215, 1963)
 FS Date: 10/15/2013

LS view: pressure relief valve on levee slope.

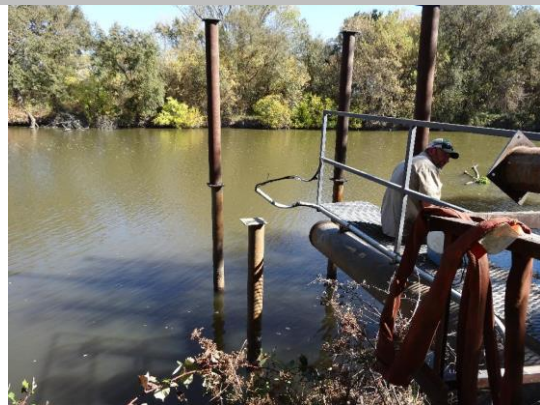
Photo 2 of 3 : UCIP_FA_2015_2382.jpg

WS view: pump platform under construction. 18" steel pipe and 2" electric conduit under steel platform.

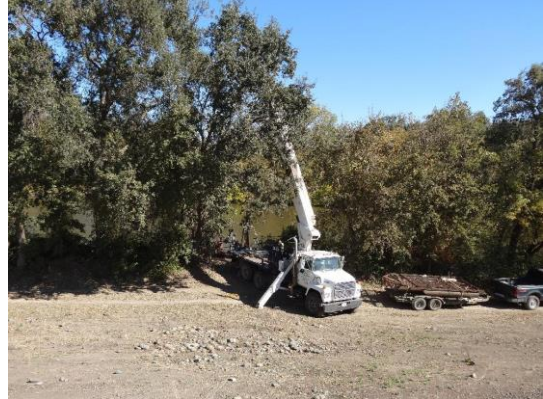
Photo 3 of 3 : UCIP_FA_2015_2427.jpg

LM Start	5.10	Rating **	M	Issue No.	10 (cont)
LM End	5.10	Issue Type +	En	Location *	LS
Category	Supplemental			GPS Latitude/Longitude	
				Start	End
Item	DWR UCIP Field Study			39.102512 °	39.102512 °
				-121.774960 °	-121.774960 °
DWR ID					
Action/Comments					
Inspector Comments: FS_ID:22705					
DS_ID:22499					
EP_NO: N/A					
FS_HLM: 5.115					
Repair Type: Non-Urgent					
Crossing Status: Found

WS view: pump platform under construction.

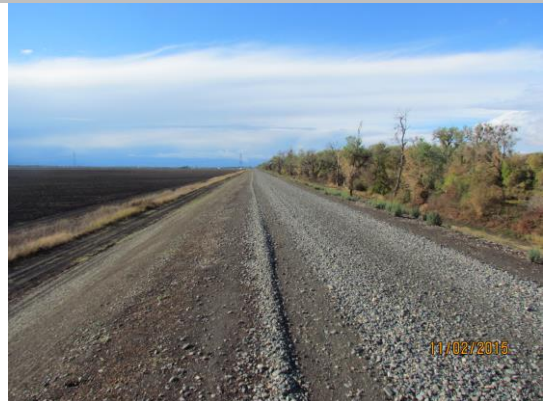
Photo 1 of 1 : FA_2015_RD1660_9_9_20151118_00008.jpg

LM Start	6.26	Rating **	A	Issue No.	9
LM End	6.26	Issue Type +	Ma	Location *	LS
Category	Earthen Levee			GPS Latitude/Longitude	
				Start	End
Item	Vegetation			39.113287 °	39.113287 °
				-121.791412 °	-121.791412 °
DWR ID	DWR_RD1660_02_f_2015_9				
Action/Comments					
Control annual grass and weeds on the levee slopes and easements. Inspector Comments: The District burned and dragged both slopes.

View of no vegetation on both slopes.
